Multiaxial Fatigue Behaviour of A356-T6

Aluminum alloy A356-T6 was subjected to fully reversed cyclic loading under tension, torsion and combined loading. Results indicate that endurance limits are governed by maximum principal stress. Fractography demonstrates long shear mode III propagation with multiple initiation sites under torsion. Under other loadings, fracture surfaces show unique initiation sites coincidental to defects and mode I crack propagation. Using the replica technique, it has been shown that the initiation life is negligible for fatigue lives close to 10^6 cycles for combined loading. The natural crack growth rate has also been shown to be comparable to long cracks in similar materials.

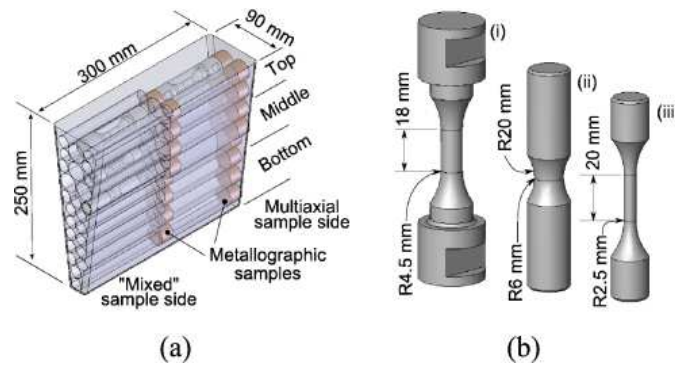
Figure 1: Wedge casting dimensions and specimen locations (a) and (b) the different types of fatigue specimens employed: tension-torsion (i), torsion (ii) and tension (iii) type.

The motivation for using a wedge-shaped casting (Fig 1a) was to create a cooling rate gradient during solidification that varied with height in the casting. A more refined microstructure was expected at the base of the casting where the cooling rate was the highest and a coarser microstructure occurred at the top where the cooling rate was the lowest. One half of the wedge was sectioned to produce tension-torsion fatigue specimens, while the other half was used to produce a mixture of solid tension, torsion and tension-torsion fatigue specimens (Fig 1b). Solid specimens were employed as opposed to tubular specimens in order to retain sampling within specific microstructural regions of the wedge. Metallographic specimens were taken such that there was at least two samples per height where fatigue specimens were cut in the wedge (Fig 1a). Additional tension-torsion fatigue and metallographic specimens were sectioned from the spokes of a Low Pressure Die Cast (LPDC) automotive wheel. All specimens were subjected to a T6 heat treatment: solutionized at 538°C for 3 hours, quenched in

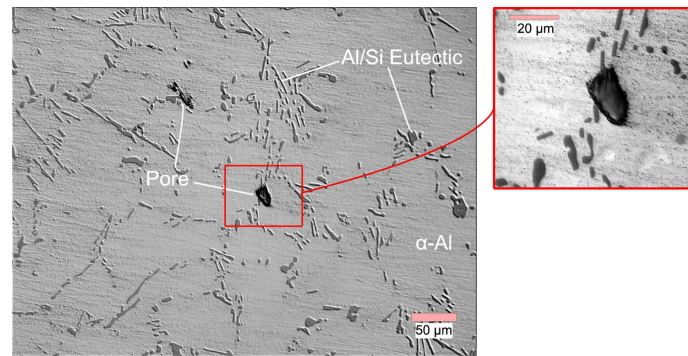
Figure 2: Typical A356-T6 microstructure showing α -Al, Al-Si eutectic phases and porosity.

Aluminum alloy A356 has an as-cast microstructure consisting of a primary dendritic structure, α -Al, filled with Al-Si eutectic phases. As the cooling rates decrease and solidification time increases, the dendritic structure coarsens resulting in larger secondary dendrite arm spacings. The T6 heat treatment serves to modify and refine the Al-Si eutectic structure. Depending on the casting conditions, the as-cast material may contain a variety of defects include gas and shrinkage porosity, and/or oxides which remain after heat treatment. Fig 2 shows optical micrographs of the typical microstructure. Metallographic analysis did not present any evidence of Fe-rich intermetallic phases known to affect fatigue properties.

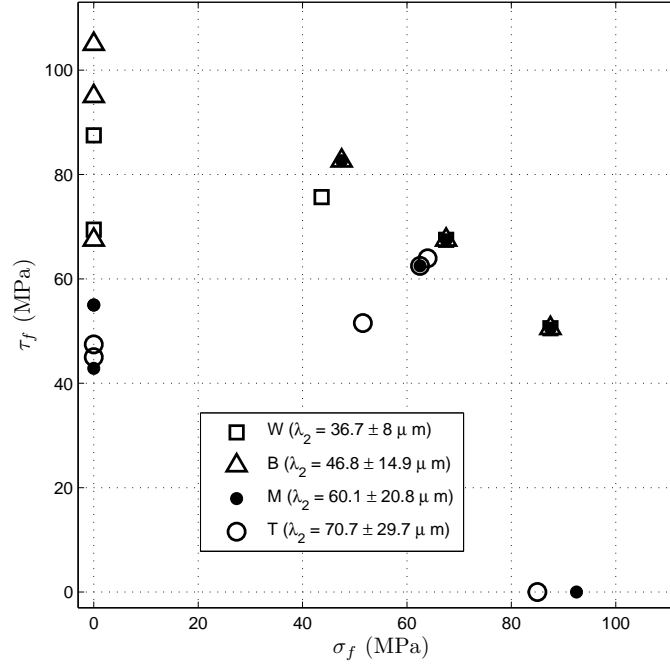
Figure 3: Fatigue limit grouped by material family type.

Grouped according to family, Fig 3 depicts σ_f versus τ_f for each specimen. Following the trend of

decreasing λ_2 from top to bottom of the wedge, the general trend is that specimens with the largest λ_2 exhibit the lowest fatigue limit. The exception was specimens extracted from the wheel, which showed a lower fatigue limit than the wedge material at a tension/torsion ratio slightly below pure torsion. However, this difference is less than the range of results shown by the pure torsion testing of the wheel specimens. Fig 4 depicts σ_a versus τ_a for all of the loading scenarios (Table 3) independent of family type. Considering the maximum fatigue limit for the entire experimental data set independent of specimen type and microstructure, σ_f and τ_f for $R = -1$ are approximately equidistant from the

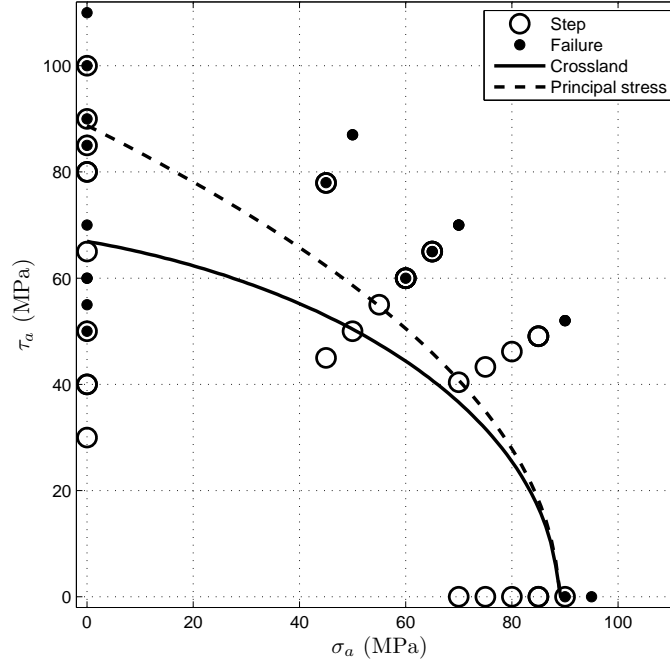
Figure 4: Fatigue test points compared to Crossland and Maximum Principal Stress criteria.

These two criteria are plotted versus σ_a and τ_a in Fig 4. Both the Crossland and the MPS criteria underestimate the measured fatigue limit for combined loading. It should be noted that the Crossland criteria approaches the MPS criteria under tension. As a result, the variance in the pure torsion results may show that the Crossland criteria applied to these results is overly conservative. Since the Crossland criterion is reliant on the determination of an accurate fatigue limit under pure torsion, the MPS criteria is the most conservative criteria to describe these results [1, 15].

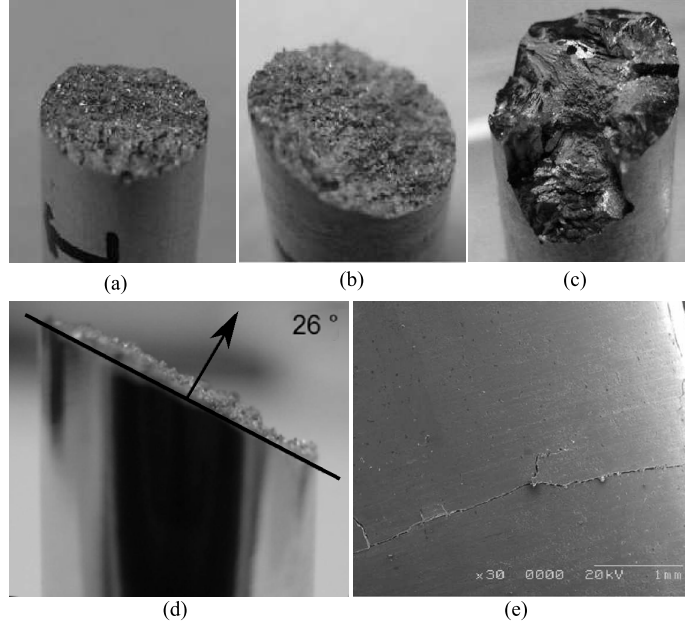
Figure 5: Failure types: (a) pure tension (b) combined tension-torsion ($\sigma_a = \tau_a$) (c) pure torsion (d) Macroscopic crack plane orientation combined tension-torsion ($\sigma_a = \tau_a$) (e) shear crack on the gauge section of the torsion sample far from the fracture surface.

A representative summary of the fracture surfaces formed for each type of loading is presented in Fig 5. Under pure tension (Fig 5a), the fracture plane was found to be always normal to the direction of applied stress and thus, coincident with the maximum principal stress ($\sigma_{1_{\max}}$) plane. Specimens from both the wheel and wedge casting exhibited this behaviour indicating that this observation is

Under combined tension-torsion loading, the fracture surface features are similar to pure tension including regular fracture planes with no bifurcation (Fig 5b) regardless of the sample location. SEM observation of the gage section far from the fracture surface reveals only small secondary cracks less than 50 μm long. The orientation of the fracture surface in Fig 5d is shown by the fracture surface normal. In this combined loading case where $\sigma_a = \tau_a$, the fracture surface normal is oriented 26° from the axis of the specimen. With the maximum principal stress acting at 31° from the specimen axis, the fracture surface normal is close to being parallel. This difference of 5° is the largest discrepancy observed over the 18 multiaxial specimens tested. Thus, the orientation of the macroscopic fracture plane under combined loading conditions correlates to the loading condition and more specifically, to the direction of the maximum principal stress ($\sigma_{1\text{max}}$). Therefore, the tension component of the loading must play a major role in deciding the path of crack propagation.

that of pure tension and combined tension-torsion loading. Fig 5c is an example of the fracture surfaces observed. The tortuous fracture surface has two major crack planes activated: one aligned with the axis of the specimen and the other one perpendicular to this axis. This highlights the difficulty in finding a unique initiation site on the fracture surface. Macroscopic observations confirmed by SEM analysis indicate that there are many different initiation sites over the periphery of the gage section and that different crack planes link together to form the final fracture surface.

The fracture surfaces of the samples tested in pure torsion were much more difficult to analyze than the pure tension samples. As shown in Fig 5c, the macroscopic topology of the surface is very complex with two perpendicular mode III cracks activated and multiple initiation sites. Initiation is spatially distributed and as a result, the fracture surface is a combination of different cracks that have coalesced to cause final failure of the sample. Thus, it was difficult to identify a single initiating feature. However, when the fracture surface was less tortuous, there were features that could be analyzed (Fig 6f). For these samples, it was non-trivial to separate the fatigue zone from final failure zone. Fig 6f shows two features that are presumed fatigue initiation sites. The feature closest to the center of the specimen is clearly shrinkage porosity with an equivalent diameter of 265 μm , located well away from the surface. The second feature is possibly an oxide film, but the features have been

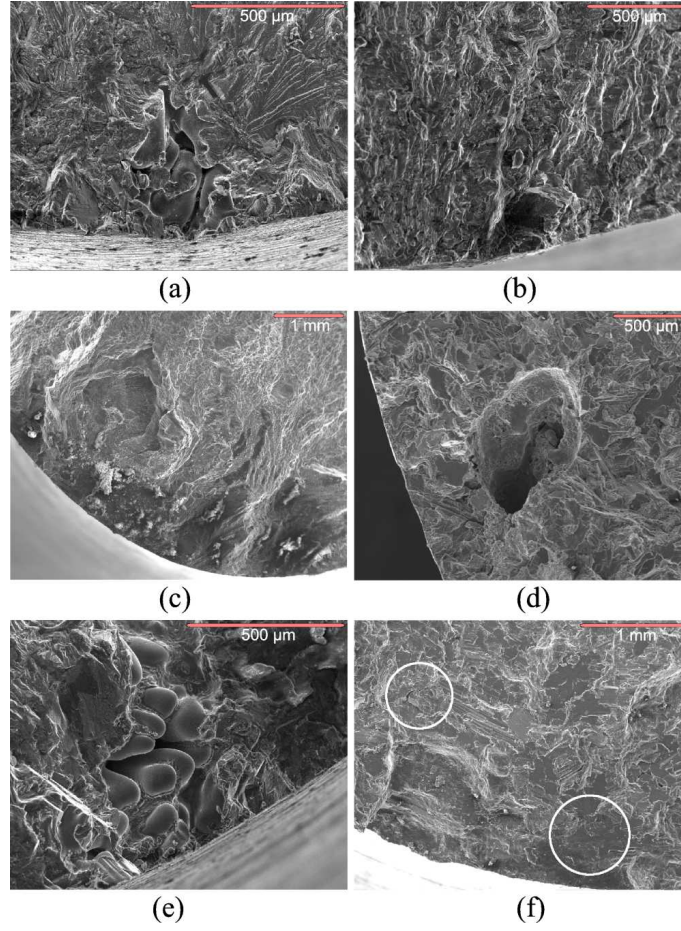
Figure 6: Fracture surfaces: (a) specimen T5, $\sigma_f = 85$ MPa (b) specimen B3, $\sigma_f = \tau_f = 68$ MPa (c) specimen W5, $\sigma_f = \tau_f = 68$ MPa (d) specimen M4, $\sigma_f = \tau_f = 63$ MPa (e) specimen T4, $\sigma_f = \tau_f = 51$ MPa (f) specimen T7, $\tau_f = 45$ MPa.

Due to the readily available tensile fatigue data for A356-T6, only two specimens were tested under these conditions. Each of these specimens exhibited a gas or shrinkage pore as the initiation site for the fatal crack. The first, M3 (Table 3), had a fatigue limit of 90 MPa and contained a gas pore with an equivalent diameter of 88 μm at the initiation site. The other specimen, T5, had a shrinkage pore with an equivalent diameter of 370 μm (Fig 6a) at the initiation site and exhibited a fatigue limit of 85 MPa.

Similar to pure tension, the combined tension-torsion samples exhibited fracture surfaces that were easily characterized. Figs 6b-e are examples of typical defects that initiated the fatal crack. Fig

6b shows the fracture surface of sample B3 that had a σ_f of 68 MPa. The initiation area on this specimen was readily identified, but a root initiating defect could not be found. Fig 6c is the fracture surface for sample W5, which had the same fatigue limit as B3. The fracture surface is less clear but it was possible to identify the initiation area where no clear defects were observed. The fracture surface instead shows friction-generated oxide associated with crack propagation. Fig 6d reveals a 500 μm subsurface pore just below the surface of specimen M4. Remarkably, the fatigue limit for M5 was 63 MPa, which is close to the highest value observed. This may be caused by the root defect location relative to the surface of the sample. When a propagating crack does not intersect the sample surface, it is not under ambient environmental conditions, but under vacuum instead. This effect has been investigated in a cast Al-Si-Cu alloy [19] where the fatigue life under vacuum when a surface defect is present is the same as when failure initiates from an internal defect of the same size. These observations have also been confirmed with nodular cast iron [20]. Therefore, a fatigue assessment of cast A356 should account for the position of the defect with respect to the free surface as there is different damage accumulation dependant on whether the defect lies on the surface or within the bulk. Fig 6e shows a typical shrinkage pore at the surface of specimen T4. In this case, a 500 μm pore decreased the σ_f to 51 MPa. This result suggests that the surface shrinkage pore is more detrimental to the fatigue life than the previous subsurface pore of the same size. However, the environmental effect is not the only factor in this case because the morphology of the defects are different.

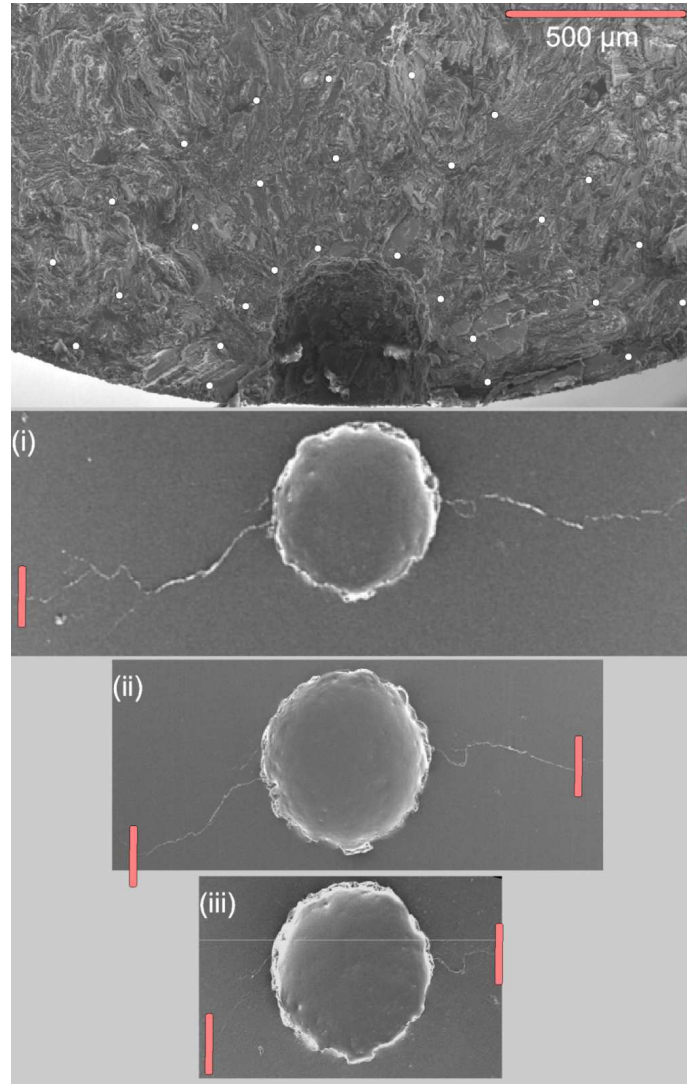
Figure 7: Tensile specimen with a 416 μm artificial defect, $\sigma_a = 90$ MPa and $N_f = 6.73 \times 10^5$ cycles. The top image is the fracture surface with crack front marking compared to surface replica at (i) $N = 3 \times 10^5$, (ii) $N = 2.25 \times 10^5$ and (iii) $N = 1.50 \times 10^5$ cycles. Replicas are oriented normal to the loading direction.

The resulting fatigue life of this sample, 673 000 cycles, indicates that the defect had an influence on the fatigue limit. The artificial defect is easily identifiable as the origin of failure on the fracture surface shown in Fig 7. The replica results in Fig 7 show the crack along the surface of the sample at 150 000, 224 000, and 300 000 cycles. Indicators identifying the extent of the crack have been added to the replica images. Through the superposition of the fracture surface and the replicas, it is possible to correlate the crack extent indicators with the fracture surface. The exact configuration of the crack with both the surface and inner shape of the crack front is tractable. As shown by the markers on Fig 7, cracking occurs on either side of the defect and the crack front passes through the defect early in crack propagation.

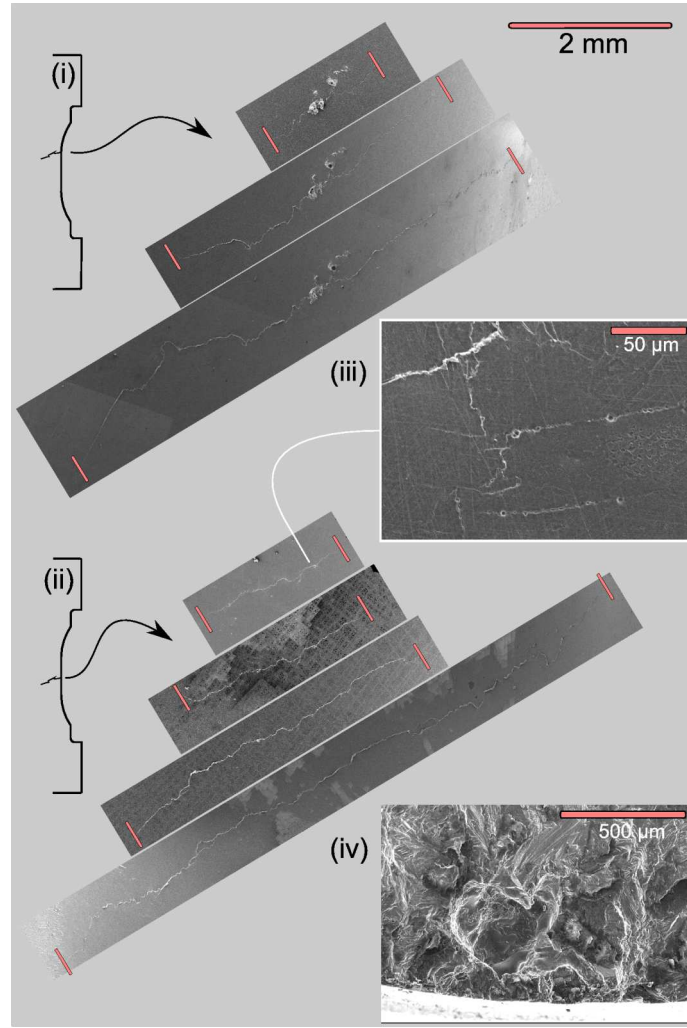
Figure 8: Multi-axial specimen T3, $\sigma_a, \tau_a = 65$ MPa and $N_f = 9.07 \times 10^5$ cycles with the secondary crack (i) at $N = 2.25 \times 10^5$, $N = 6.75 \times 10^5$ and $N = 8.75 \times 10^5$. The primary crack (ii) is shown at $N = 2.25 \times 10^5$, $N = 3.75 \times 10^5$, $N = 6.75 \times 10^5$ and $N = 8.75 \times 10^5$. Damage accumulation (iii) was found to occur at the initiation zone and a 300 μm defect (iv) was found on the fracture surface.

presented in Fig 8. The crack path is regular and the propagation plane normal of both cracks is oriented at 31° from the central axis of the specimen. This is consistent with other tests of the same type (Section 4). Fracture surface analysis revealed a gas pore with an equivalent diameter of 300 μm just below the gage surface. Since this specimen had the same fatigue limit (68 MPa) as a specimen where a defect could not be identified, it is assumed that this pore had minimal effect on the fatigue limit. The secondary crack observed on this sample initiated at a gas pore, visible on the surface of the specimen, near the beginning of loading and grew in the same orientation as the main crack.

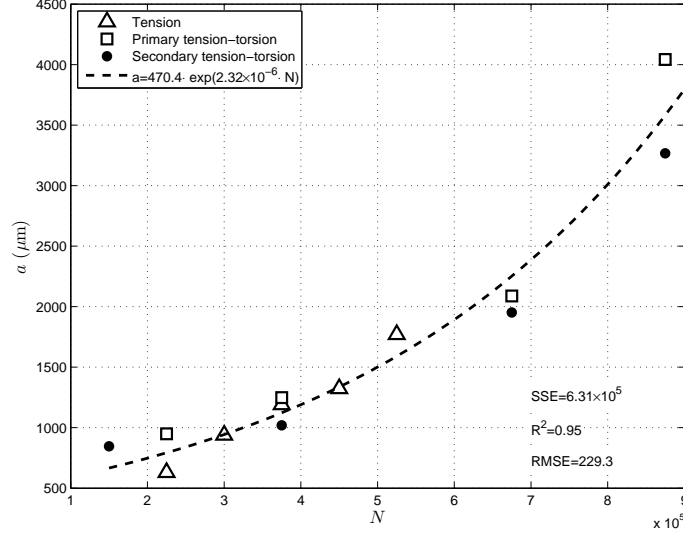
Figure 9: Crack growth law under tension and tension-torsion.

Fig 9 shows the evolution of the crack length a versus the number of loading cycles, where a is half of the crack length measured from the replica. The estimated accuracy of these crack length measurements is $\pm 5 \mu\text{m}$. While the crack length data in pure tension is for a test with $\sigma_1 = 90 \text{ MPa}$, the multiaxial test data is for $\sigma_1 = 105 \text{ MPa}$. Assuming that σ_1 is the governing parameter for crack growth, these two tests are not strictly comparable as the stress state for each is different. However, this difference is relatively minor and the natural crack growth behaviour exhibits a very small difference in crack growth versus cycle count despite the different stress states. Therefore, the crack growth data in Fig 9 demonstrates the intrinsic short crack growth behaviour of this alloy. Consequently, the aggregate crack growth data has been used to fit an exponential relationship according to:

where $2a$ is the surface crack length, N the number of cycles with α and β fitting coefficients. As the short crack growth behaviour shows inherent variations, this exponential fit characterizes the average short crack growth curve with $\alpha = 470.4$ and $\beta = 2.32 \times 10^{-6}$ (Fig 9). The crack evolution described by Eq. 3 lacks the non-linear behaviour associated with initiation. However, based on the degree this equation represents the crack growth data, it is apparent that propagation dominates the fatigue life for A356-T6. The investigation of precise correlations for the initiation stage of the fatigue life of A356-T6 has demonstrated that fatigue initiation can be neglected for pure tension[4]. For fatigue lives close to 1 million cycles, the present findings assert that fatigue initiation may be considered negligible regardless of loading condition.

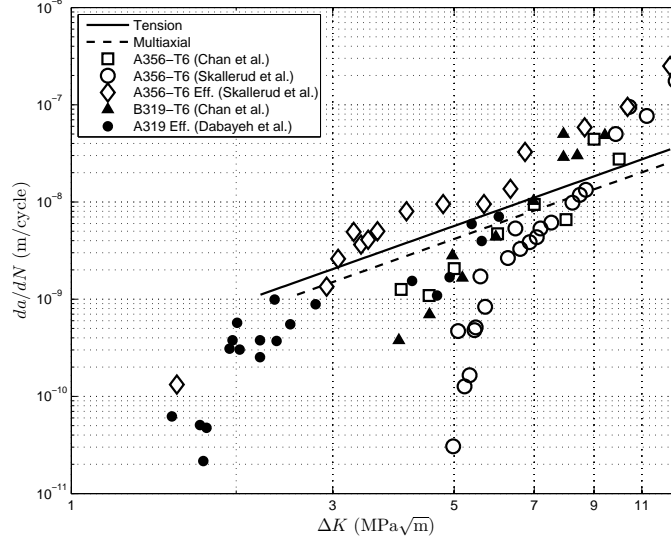
Figure 10: Comparison between effective long crack growth behaviour and natural crack growth behaviour.

The crack growth rates are plotted against the amplitude of the stress intensity factor in Fig. 10. The crack growth rates for each stress state were determined from the fitted data (Eq. 3). The stress intensity factor was computed assuming a semi-circular crack front, where $K = \phi\sigma_1\sqrt{\pi a}$ with $\phi = 0.643$ [22, 33]. The results for the two stress states are compared against studies performed on A319 [28] by Dabayeh et al., B319-T6 and unmodified A356-T6[29] by Chan et al., and peak-aged A356-T6 [2] by Skallerud et al. [2]. These four data sets for similar materials with different load ratios are plotted to provide references for short, long, and unstable crack growth behaviours.

difference between ΔK and ΔK_{eff} for A356-T6. The tensile and multiaxial crack growth rates from the current study are approximately the same as that of ΔK_{eff} Skallerud et al., which reinforces the short crack categorization microstructure, as it has been found appropriate to employ a closure-free K value to describe short crack behaviour [34, 35].

where da/dN is the crack growth rate in meters per cycle and ΔK is the positive component of the load cycle in MPa $\sqrt{\text{m}}$. As da/dN versus ΔK for both natural cracks analyzed via the replica technique (Fig 10) show good agreement with aggregate long crack data for similar alloys, the MPS assertion is further validated.
